PBY Catalina

Walk Around Number 5
squadron/signal publications

By William Scarborough
Color by Don Greer
Illustrated by Joe Sewell

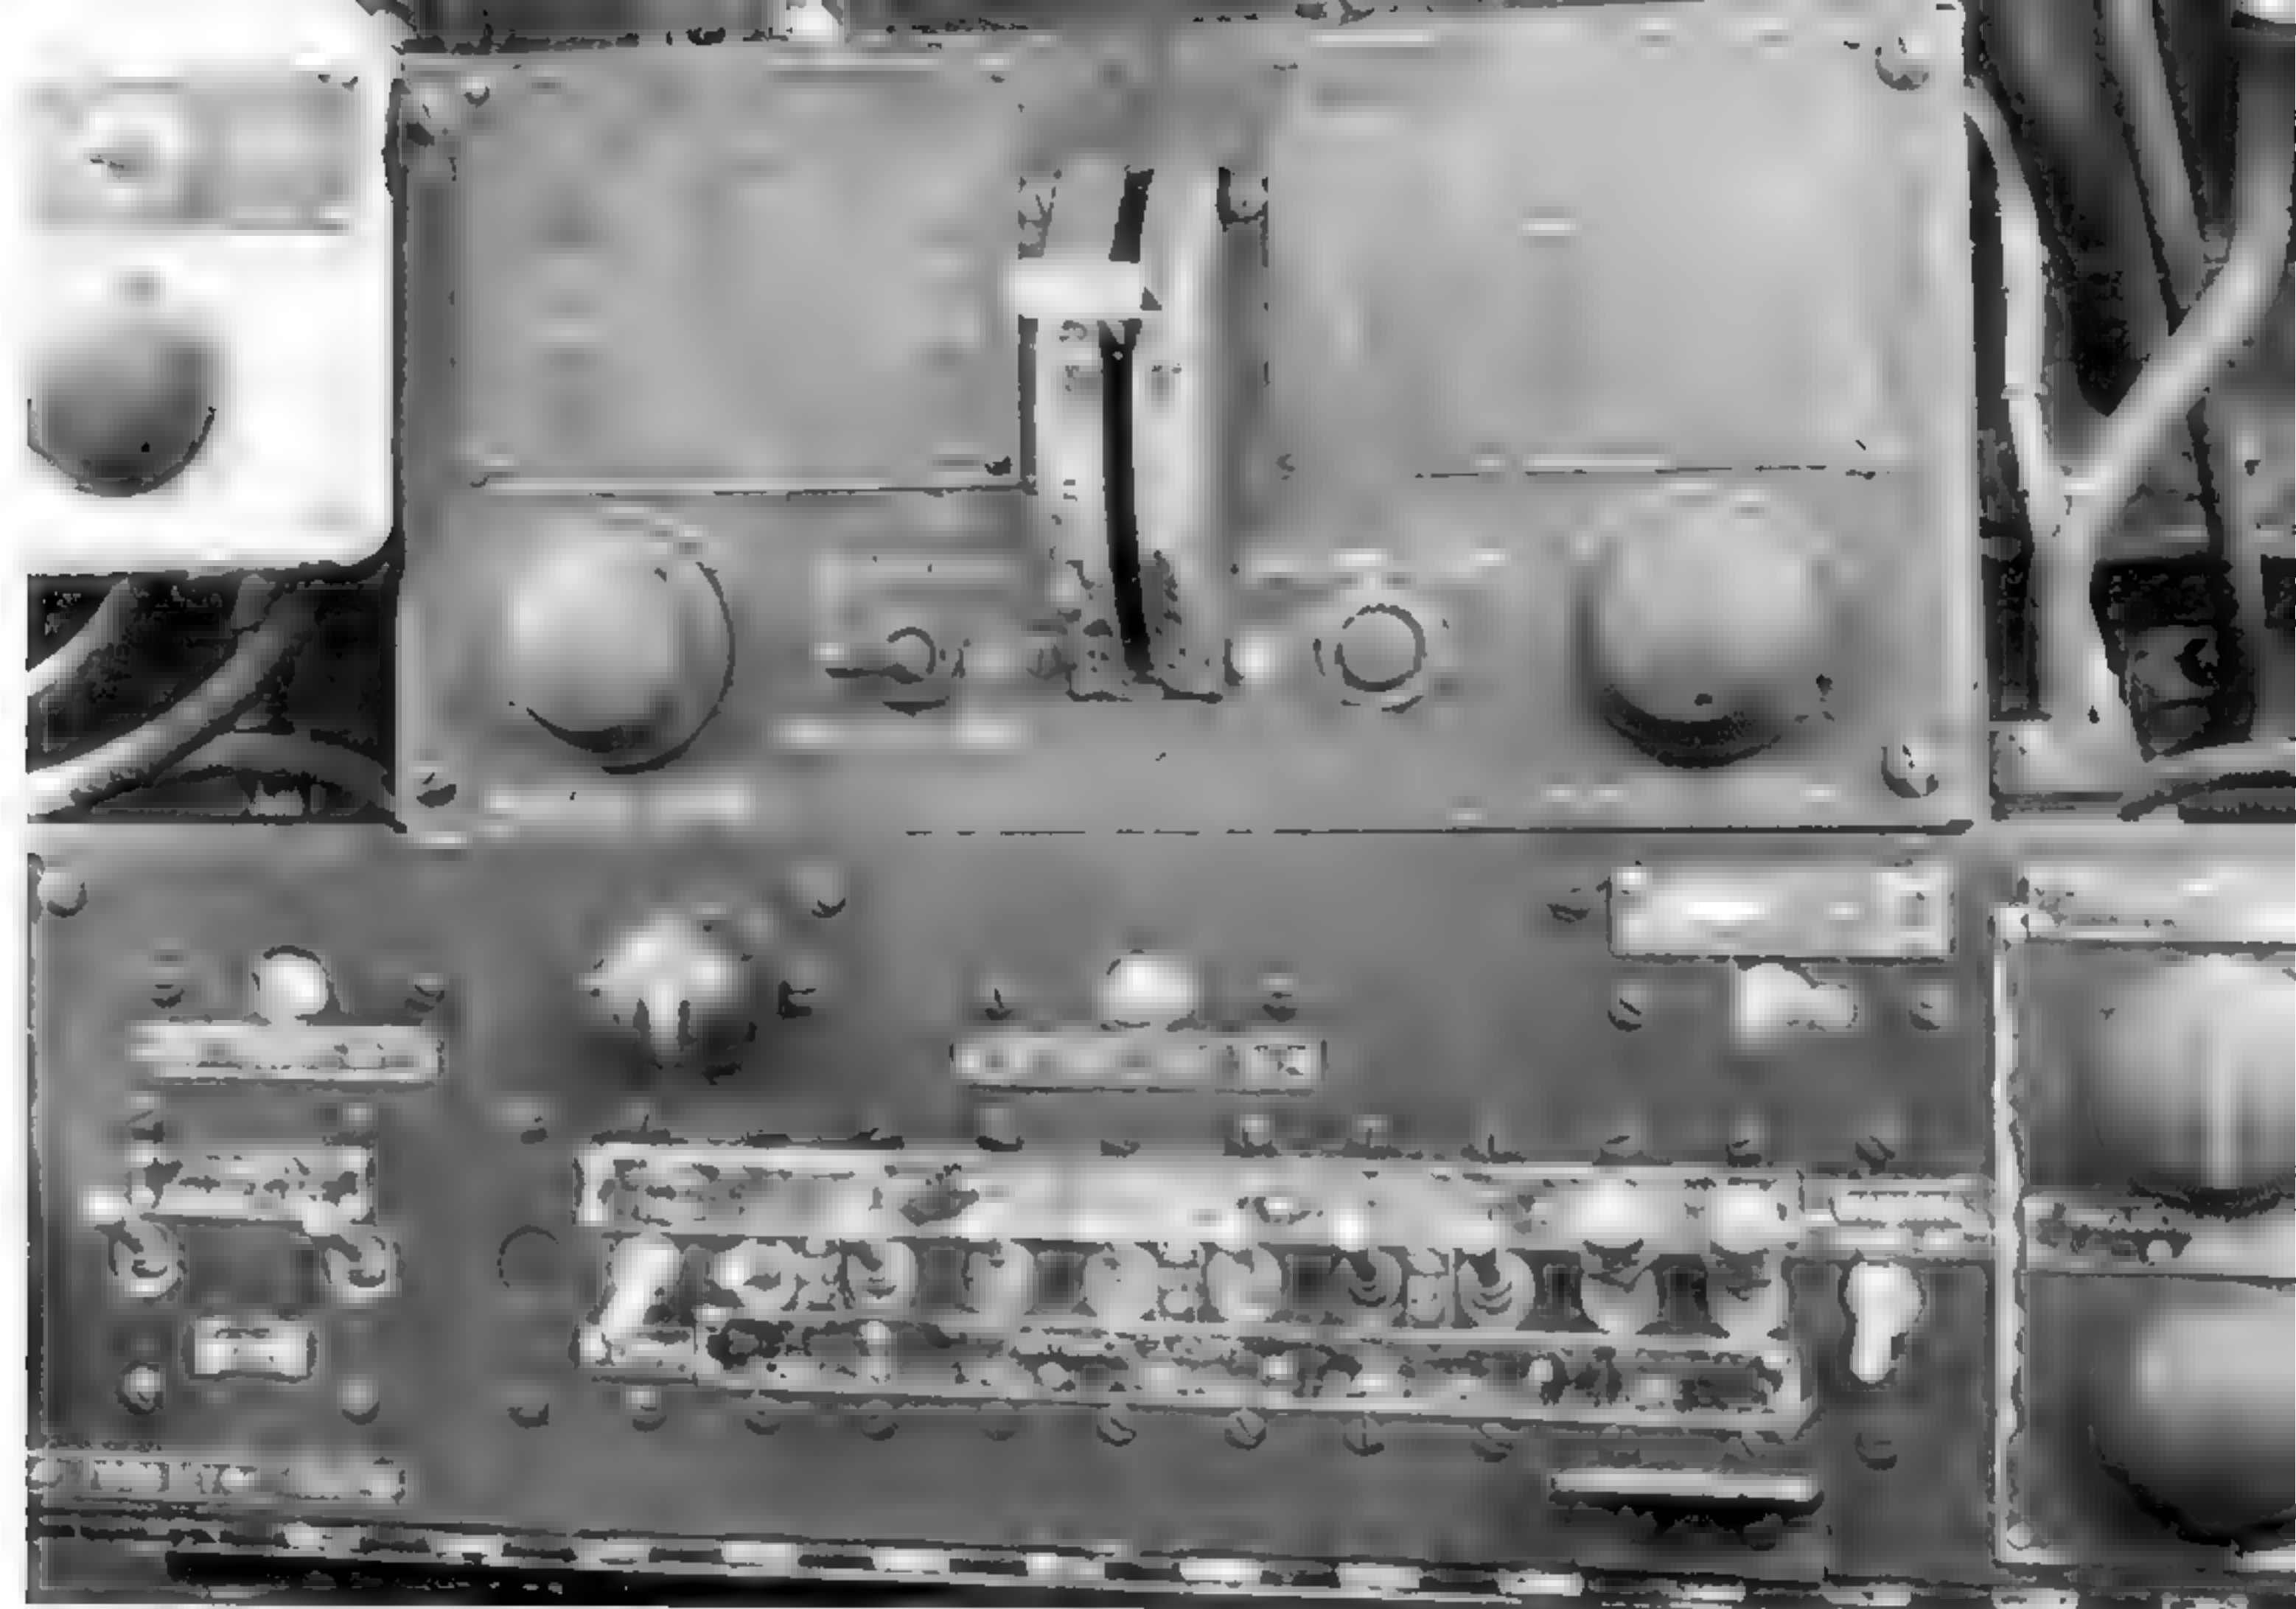
The panel installed at the top of the bulkhead behind the pilot's seat contained the controls for Intercom and Radio, on the top panel and the lighting controls (interior and exterior) on the lower panel. The receptacle for the remote "Pickle Switch" for bomb and torpedo release was located to the left of the lighting panel. (Author)

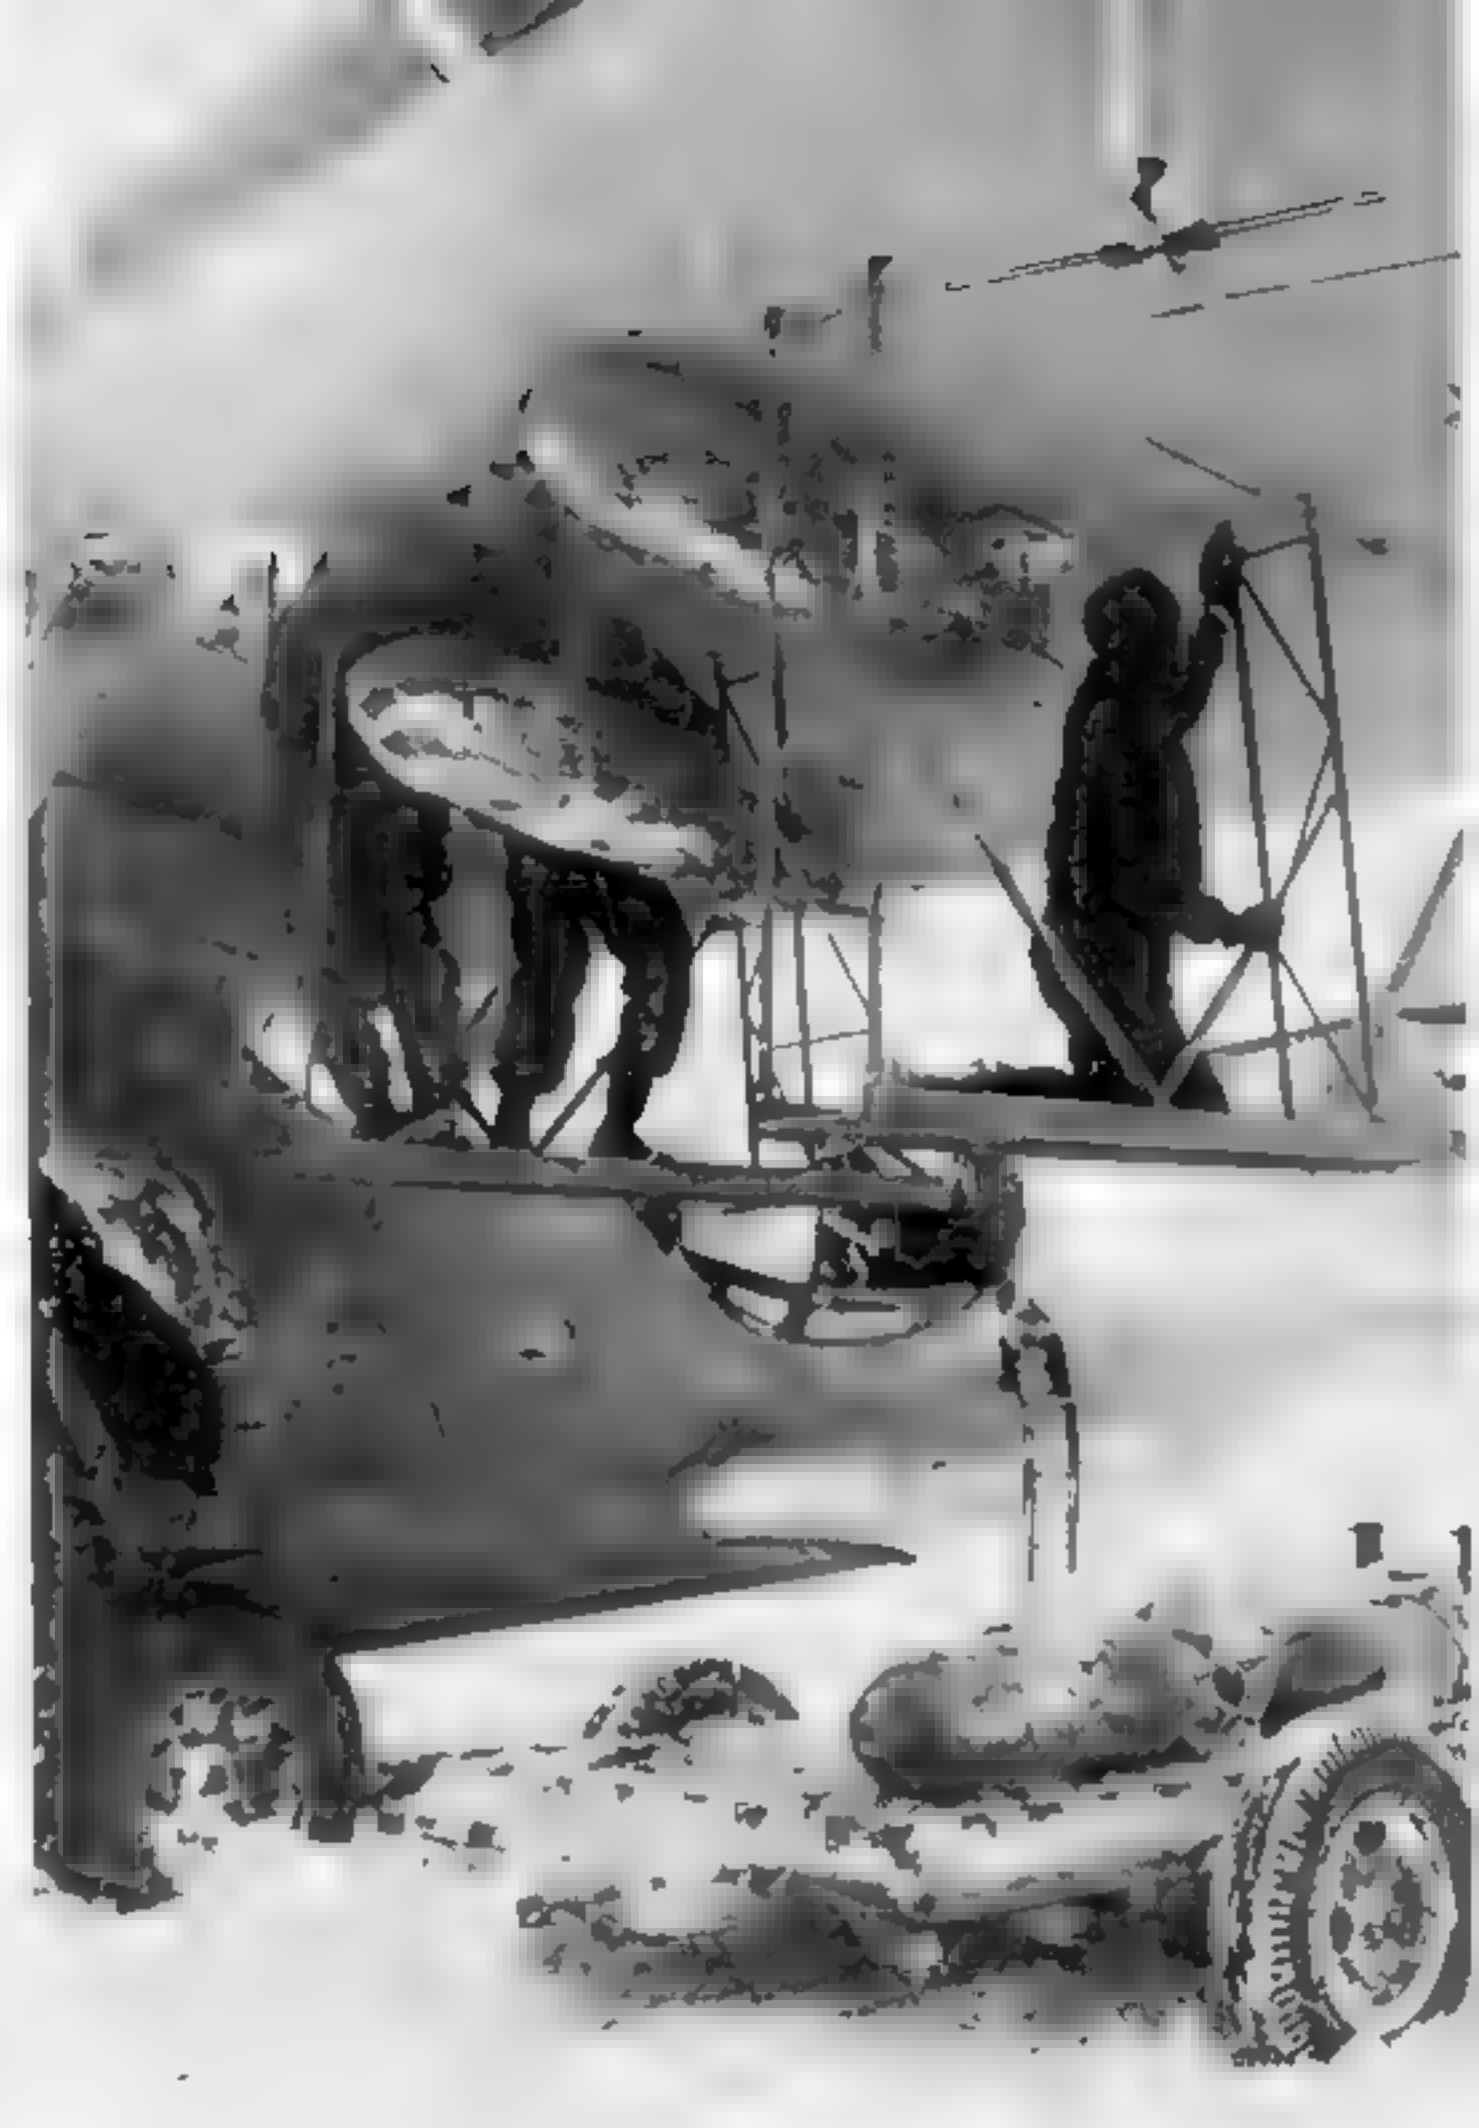
These crewmen are loading 500 pound General Purpose bombs on the underwing racks of a PBX-5A under harsh conditions at Cold Bay, Alaska on 23 November 1942. The antenna above the crewman at the right is a Yagi radar antenna. (George E. Earle)

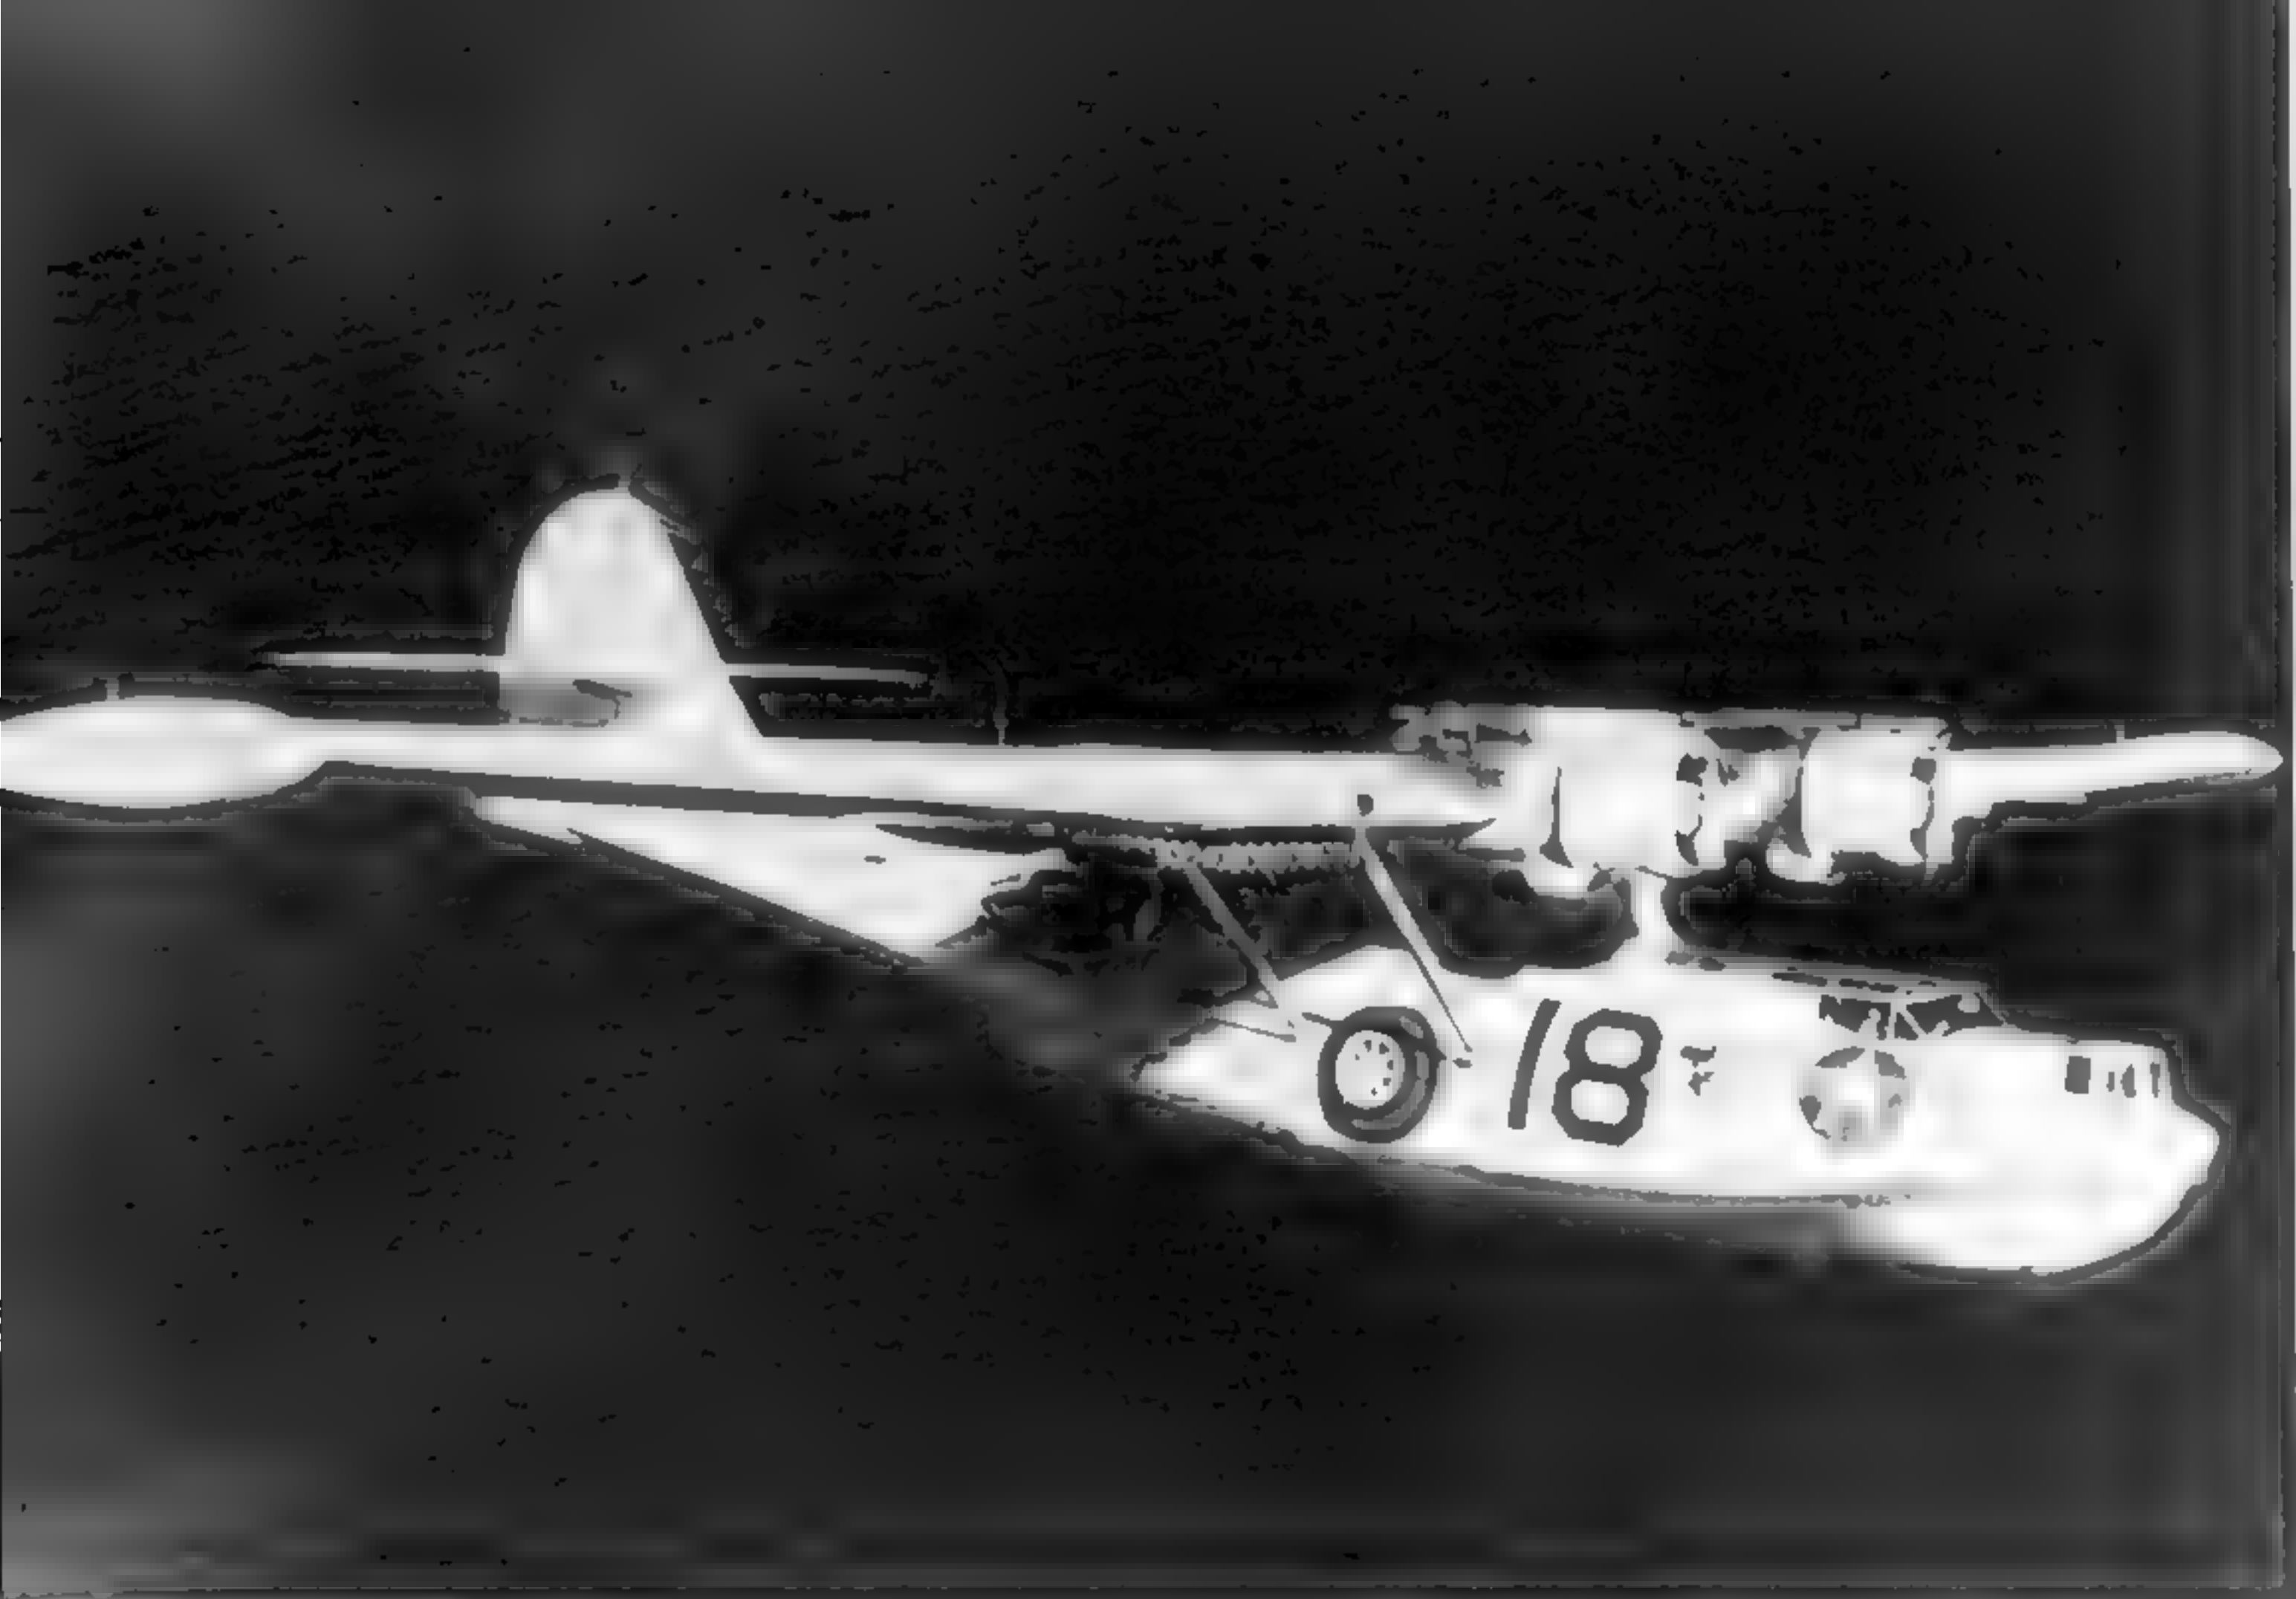
PB4Y-5A, side number 18 of VP-63 during 1944, is fitted with tail mounted MAD gear. The aircraft is armed with anti-submarine retro rockets under the wings and has exhaust shrouds fitted for thermal wing deicing. The aircraft was painted in the anti-submarine scheme of Sea Gray upper surfaces over White. (USN

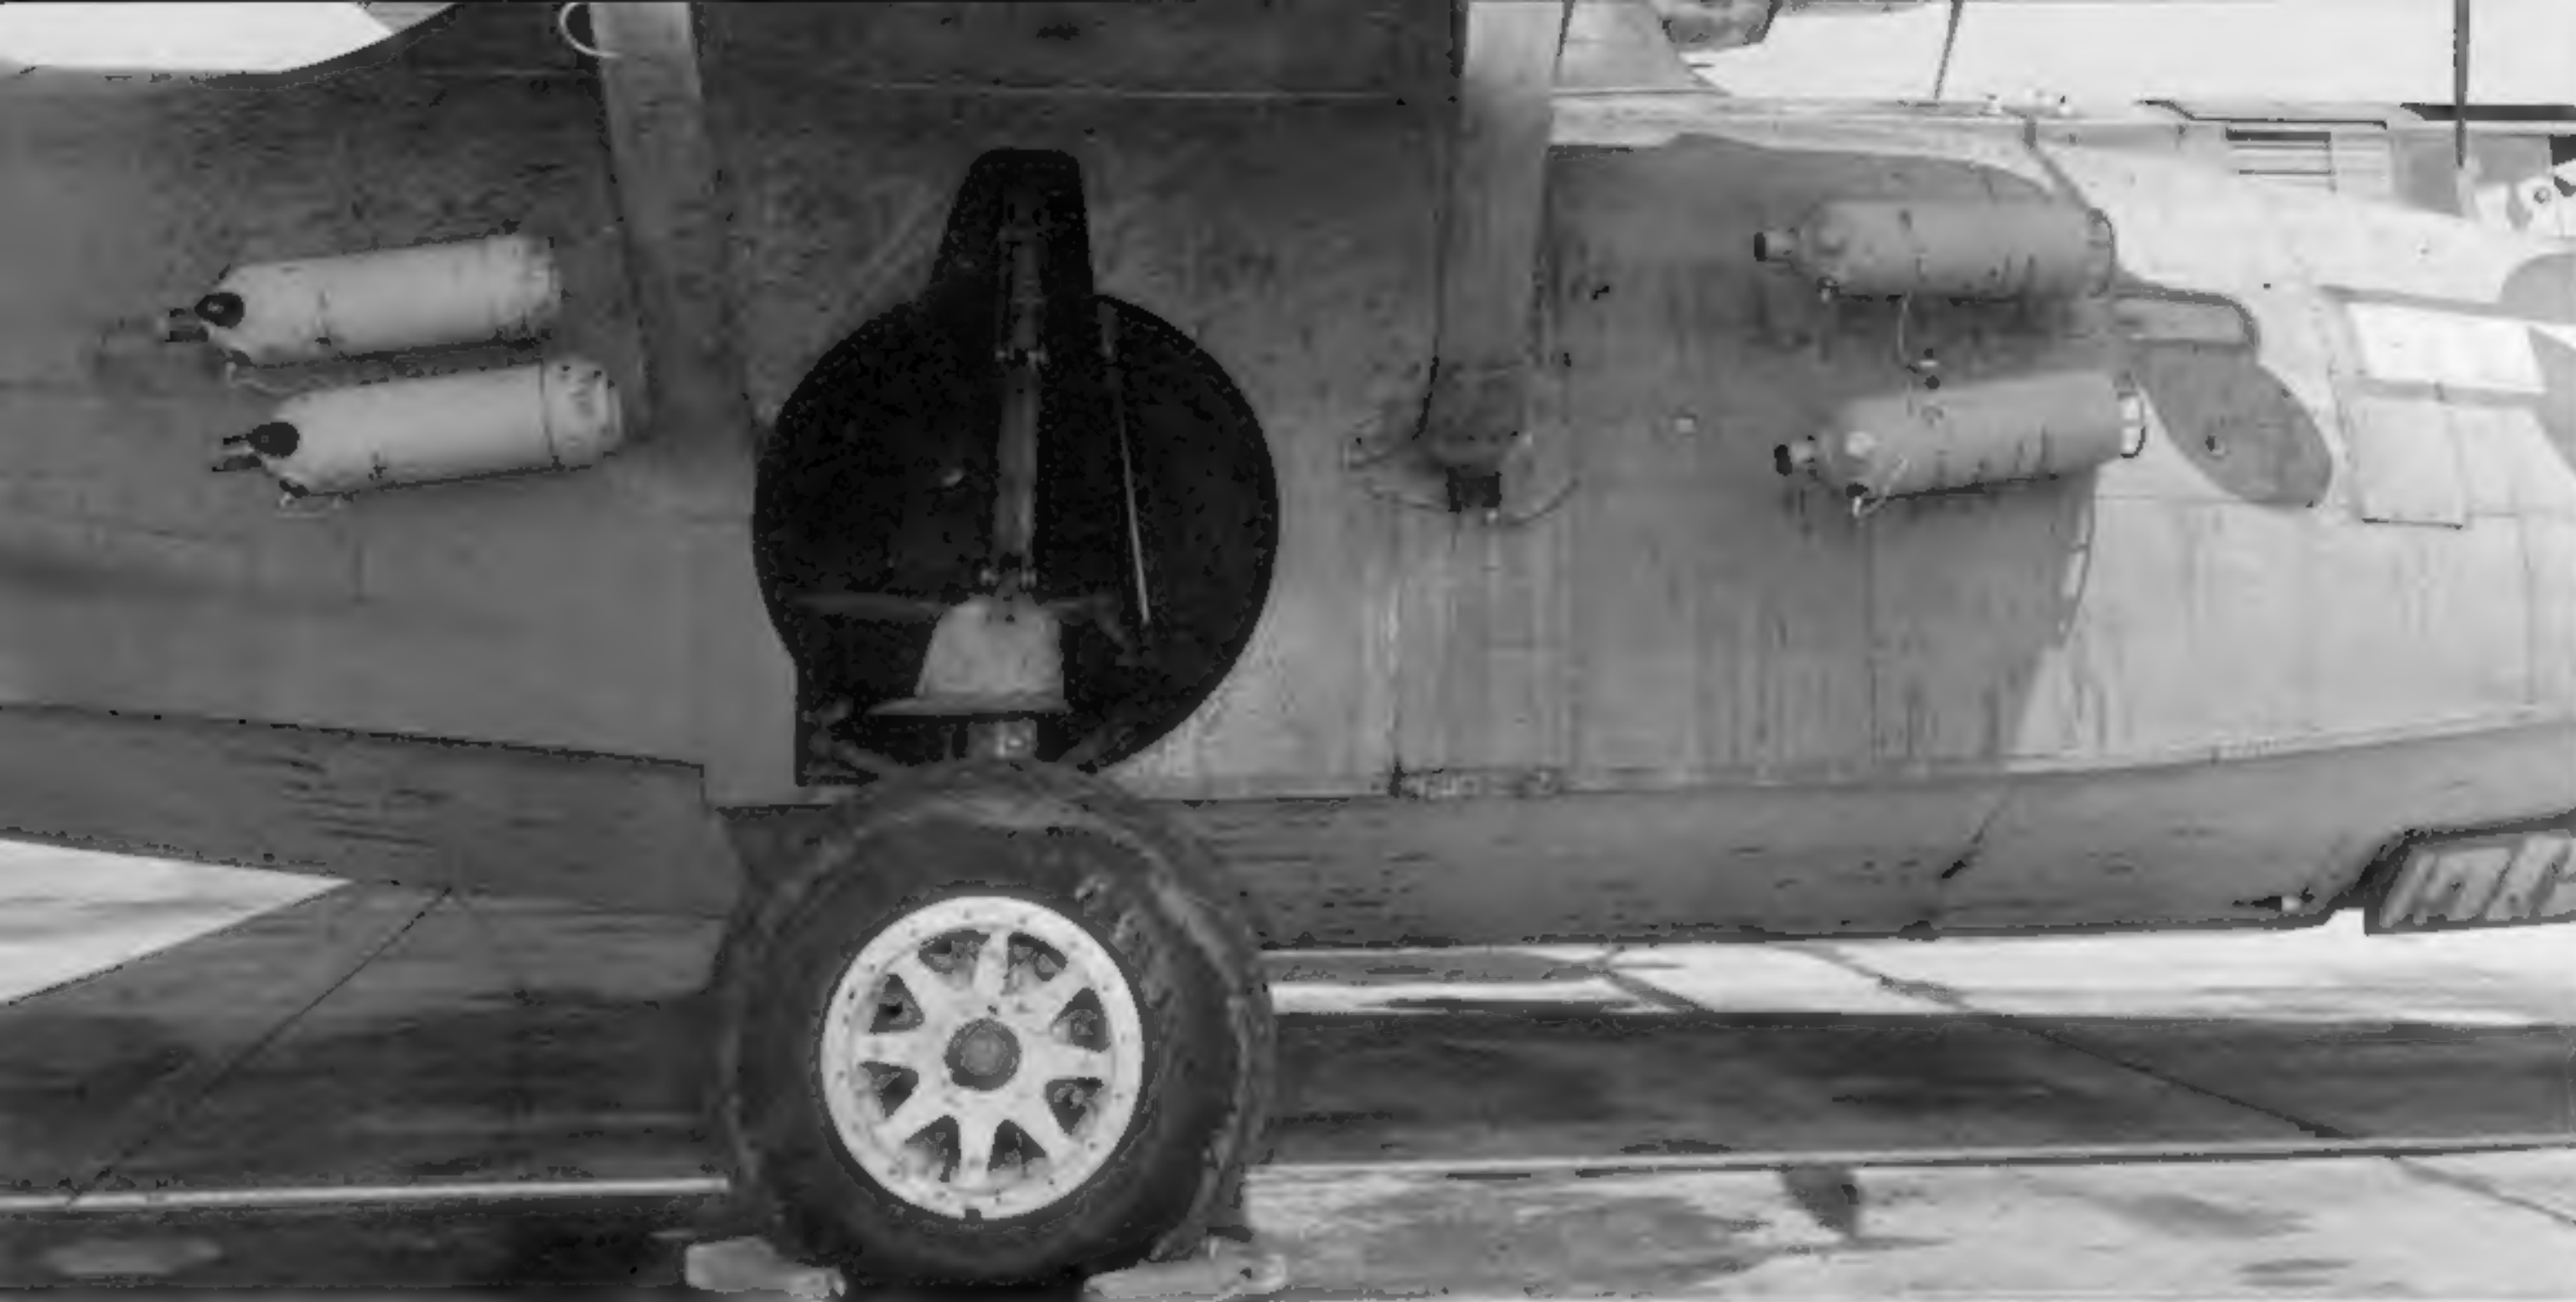
The starboard Jet Assisted Take Off (JATO) bottle installation on a PBY-5A (BuNo 04406) on 2 June 1945. The aircraft could carry eight JATO bottles, four on each side and these could be fired either all at once, or in pairs (forward and aft). (USN)

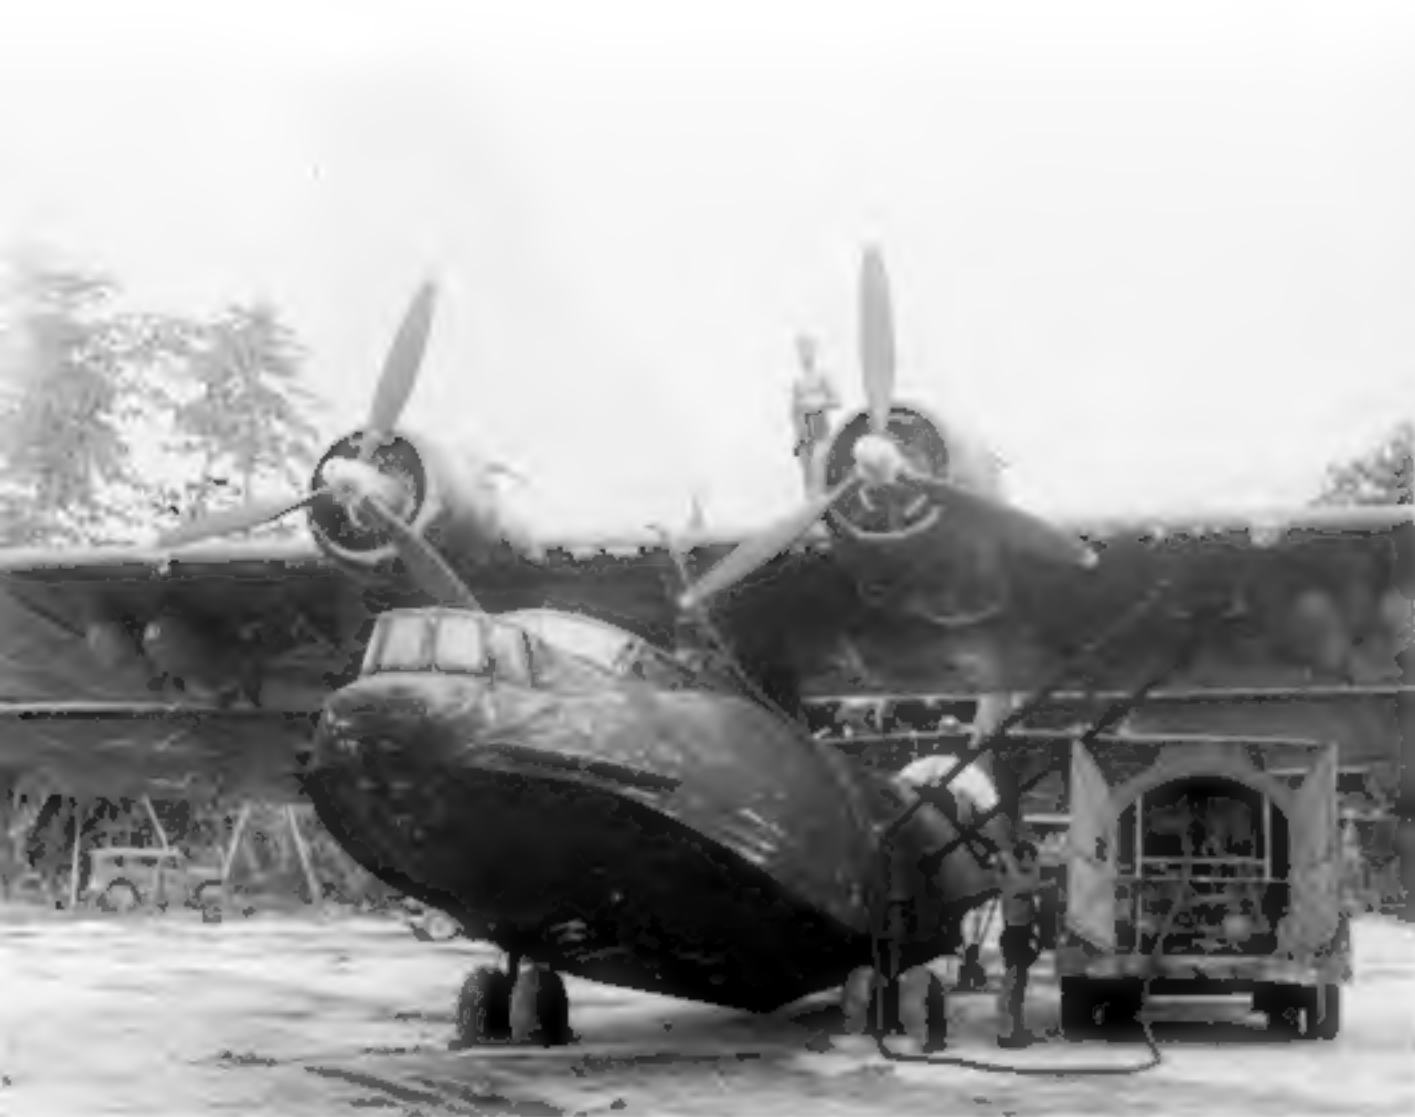
A PBX-5 Black Cat of VP-34 was shore-based at Samarai, on 3 March 1944. It was outfitted with an experimental fixed nose gun battery of four .50 caliber guns. Its typical bomb load was made up of 500 pound bombs hung outboard and 1,000 pound bombs hung inboard. (National Archives via Dave Lucabaugh)

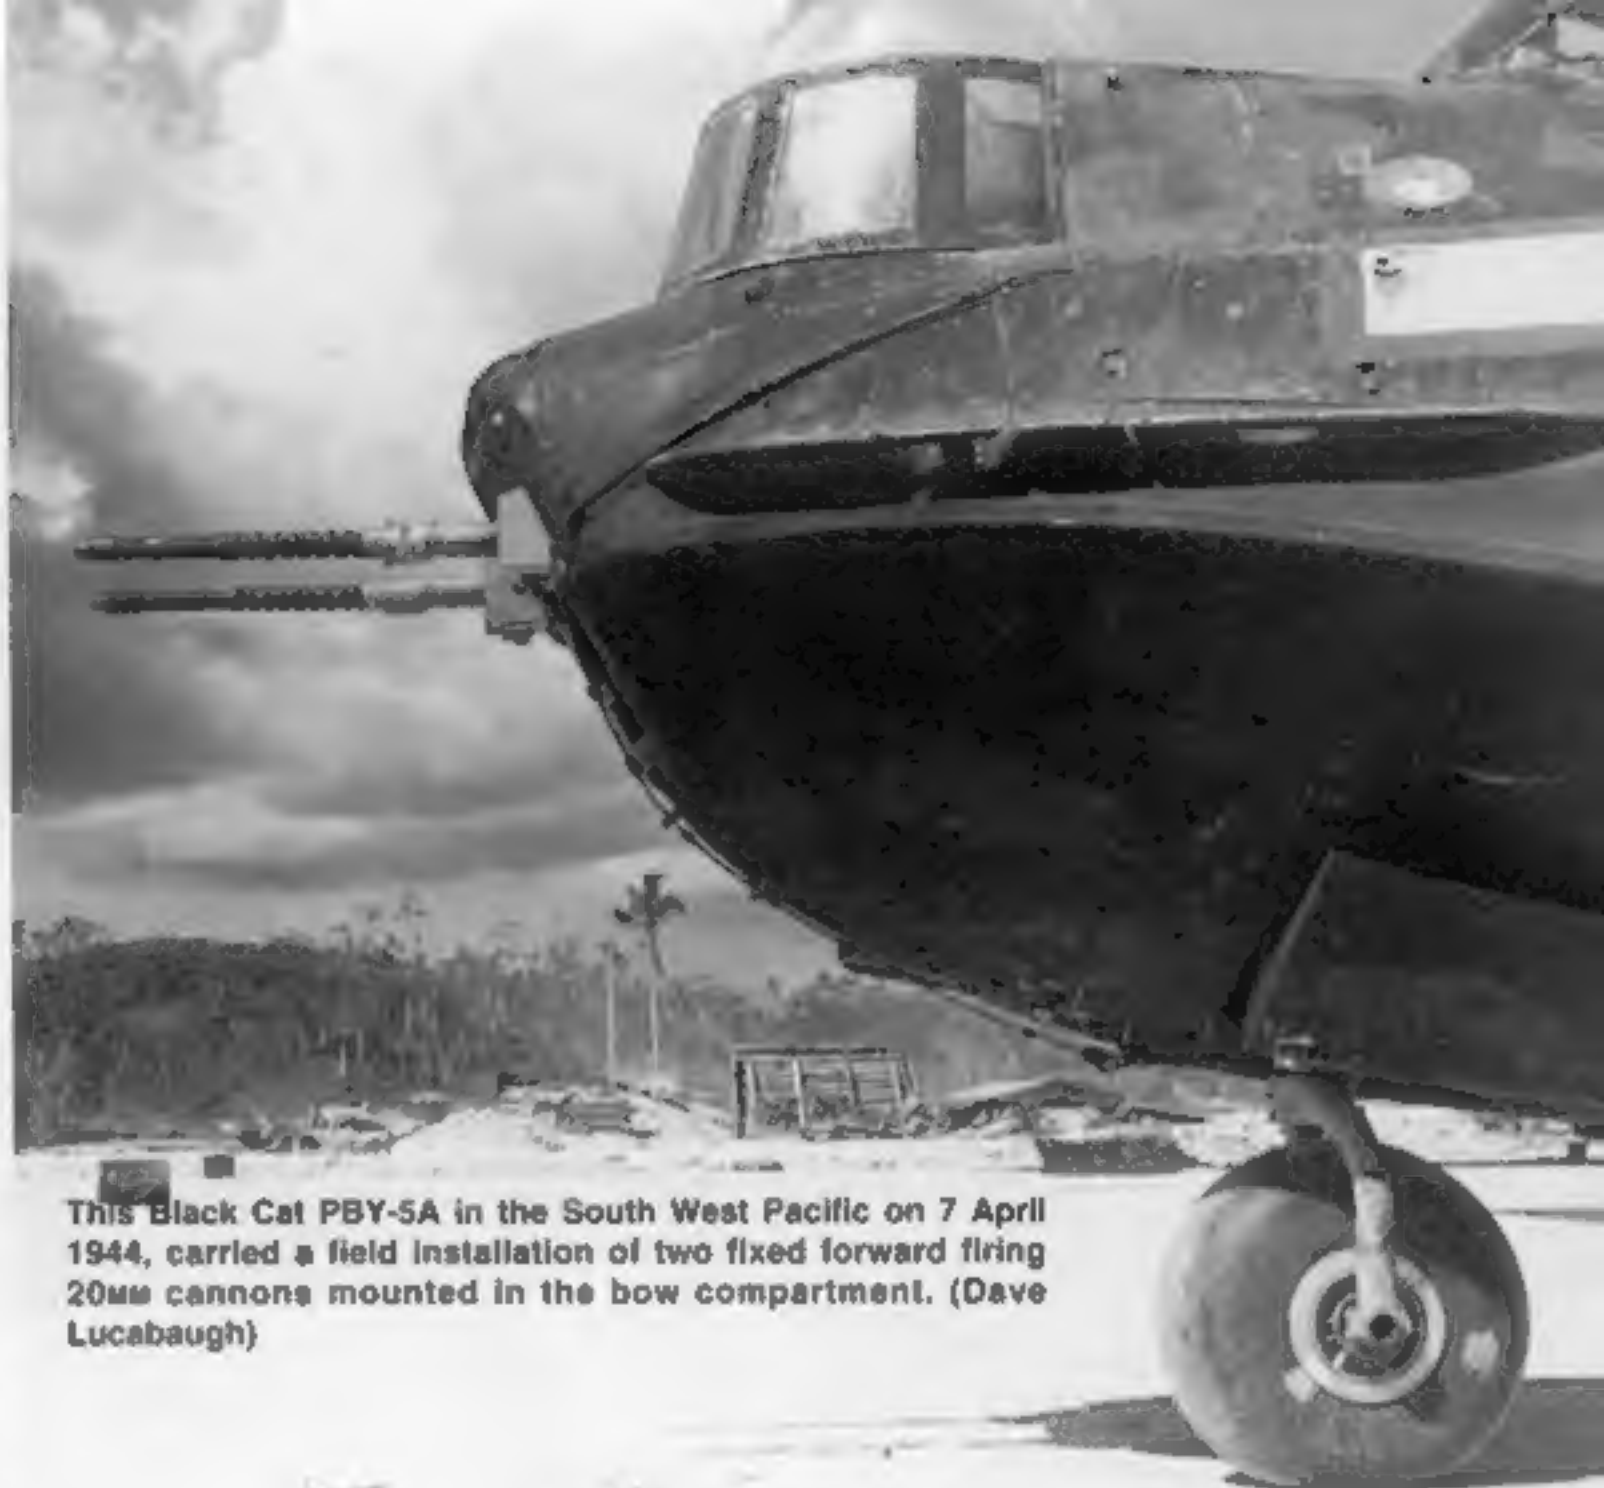
This Black Cat PBX-5A in the South West Pacific on 7 April 1944, carried a field installation of two fixed forward firing 20mm cannons mounted in the bow compartment. (Dave Lucabaugh)
